# R. J. WHITFIELD & ASSOCIATES, INC.

## REPORT OF CONDITION AND VALUATION SURVEY for purposes of insurance evaluation

Survey #11/10-XXXX  
1973 Westsail 32  
Survey performed for XXXX, owners,  
with the vessel afloat,  
on 01 November 2010

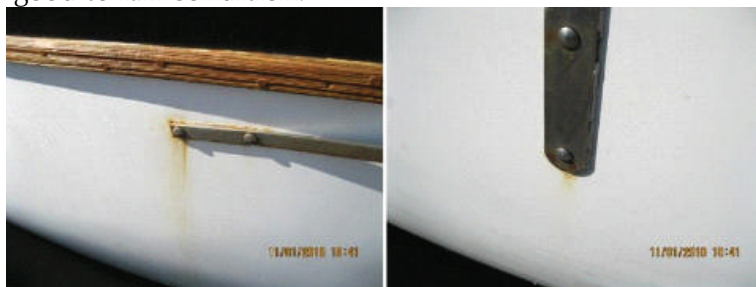
Construction material: Fiberglass  
 Stem: Flared, although vessel is double ended  
 Cap rail(s): Teak  
 Transom: Double ended  
 Hull cosmetics: Hull cosmetics are in good to fair condition.  
 NOTE: Some rusting

fasteners noted (chain plate and Martingale) -- *remove fasteners, inspect and correct condition, as required.*

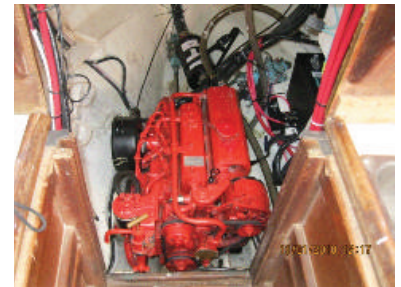
Type: Inboard  
 Manufactured by: Beta Marine  
 Serial number(s): 4N3608  
 Model number(s): BV1505  
 Naturally aspirated? Yes  
 Horsepower: 17.5 HP  
 Number of cylinders: Four  
 Year: 2006 (reportedly)  
 Engine(s) location(s): Cockpit bilge  
 Engine space hatch(es): Beneath companionway steps  
 Fuel type: Diesel  
 Fuel pump(s): Engine mounted  
 Fuel filter(s): Beta Marine 211-60210  
 Hoses and clamps: Good  
 Belts and pulleys: Good, although belt appears to be rubbing in way of the alternator -- *correct as required.*  
 Engine mounts and beds: Sound  
 Throttle and shift control(s): Single lever  
 Alternator(s) approved type: Yes  
 Drip pan(s) beneath engine(s): No -- *recommend installation of a drip pan or oil absorb pad.*  
 Cooling system(s): Heat exchanger cooled -- coolant level is low (no anti-freeze) -- *recommend adding anti-freeze as a corrosion inhibitor.*  
 Oil level and condition: Oil is dirty -- *recommend oil change.*

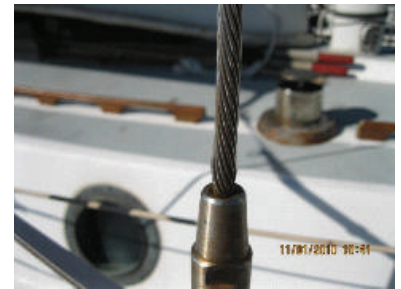
Stay or shroud: Main forestay is 5/16" 1 x 19 S/S wire  
 Main upper shrouds are 5/16" 1 x 19 S/S wire -- the port shroud is reportedly new -- displaced wire noted at the lower end of the starboard shroud -- *monitor and correct if condition worsens.*
