# R. J. WHITFIELD & ASSOCIATES, INC.

## REPORT OF CONDITION AND VALUATION SURVEY for purposes of insurance evaluation

Survey #11/10-XXXX  
1973 Westsail 32  
Survey performed for XXXX, owners,  
with the vessel afloat,  
on 01 November 2010

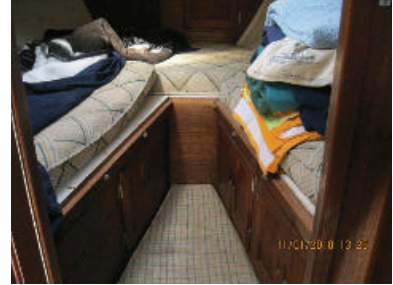
Curtains: No  
 Heating/Air conditioning: Wood stove in the main saloon, with appropriate heat shield on the bulkhead  
 Smoke detector(s): No -- all vessels 26 feet or more in length, with accommodation spaces intended for sleeping, shall be equipped with a single station smoke alarm -- *provide a minimum of one smoke alarm (per NFPA 302-44.12.3).*  
 Carbon monoxide detector(s): Yes -- operational  
 Flammable(s) stored inside cabin: Yes -- *remove all flammable products from interior storage.*  
 Flooring: Occasional rugs have been placed in heavy traffic areas. Flooring is painted plywood panels.  
 Upholstery: Cloth  
 Condition: Interior is in good condition for its age.  
 Window leakage?: Yes -- *ensure watertight integrity of starboard forward port light and re-seal if required.*  
 Chain plate(s) leakage?: No evidence sighted.

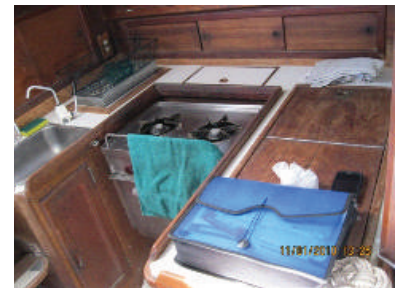
Stove: 2 burner alcohol -- stove to be replaced, most probably with a propane unit

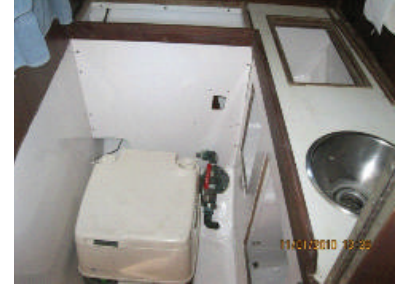
Number of heads: Lavac head (original) to be re-installed --  
Thetford Porta Potti presently in place

Toilet(s): Manual  
Type(s) of marine sanitation device(s): Type III -- when operating this vessel on a body of water where the discharge of untreated sewage is prohibited by the EPA under 40 CFR 140.3, the operator must secure each Type III device in a manner which prevents discharge of sewage -- this may be accomplished by: 1) closing each valve leading to an overboard discharge and removing the handle; 2) padlocking each valve leading to an overboard discharge in the closed position; or 3) using a non-releasable wire tie to hold each valve leading to an overboard discharge in the closed position -- *recommend securing as/if required (per 33 CFR 159.7.2.c).*
