# Grounding and Bonding in Boats and Marinas

## A Vital Link to Safety

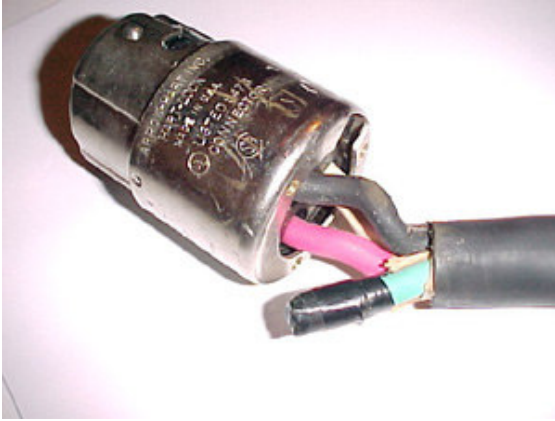
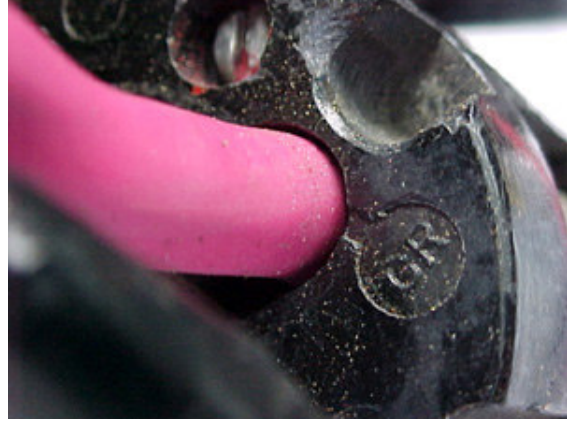
A recent incident should set the stage for our discussion. A quiet Memorial Day weekend turned tragic when a houseboat owner decided to install a new female plug on his shore cord so it would be compatible with his inlet receptacle. His boat was wired for 120vac but the cord was set up to supply 240vac. Please examine the result of his handiwork in the below pictures. Note that the green ground wire in first picture is taped back and not connected to the plug. In the second picture you can see that he inserted the red wire (the hot, ungrounded conductor) into the hole for the ground wire effectively electrifying the aluminum hull (and water surrounding the boat) *while eliminating the ground wire fault current return path.*

His wife and daughter were sunning themselves on the boat when they decided to go for a swim to cool off. After entering the water adjacent to the boat, they were both overcome by electric shock and drowned by the electric field established in the water.

This tragedy was the result of a ground fault and a loss of ground connection at the same time. This combination is what has resulted in numerous deaths in freshwater marinas nationwide. AC ground faults, along with ground system problems also result in boat fires each year. Faults in the bonding system of a boat, coupled with DC ground faults, contribute to significant cases of underwater metal corrosion.

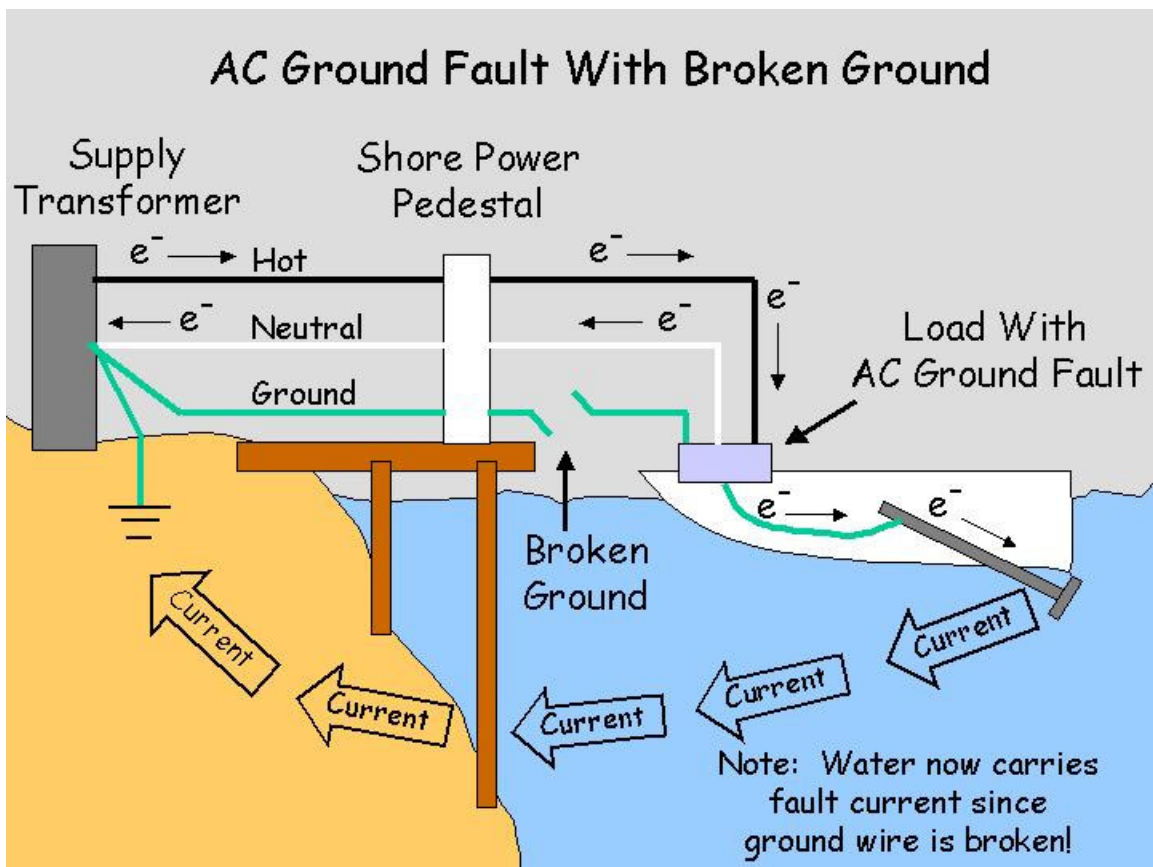
From the above discussion we have revealed another source of personal injury; the electric field in the water caused by AC ground faults. The good news is that this is of little consequence in saltwater since the water is so conductive that the human body does not represent a lower resistance path for current to flow. However in freshwater, AC ground faults are a real threat, and in fact are killers. Remember that as long as the green ground wire back to the source is of low enough impedance, water currents will be low and create little voltage gradient. NFPA 303 (reference by NFPA 70) specifically addresses this situation by requiring that the ground systems in all marinas be checked for integrity at least annually, along with visual inspections of marina wiring for compliance with code requirements. It also forbids personnel from entering the water in any marina where shore power is provided. Complying with NFPA 303 substantially reduces the likelihood of electric shock drowning. Please see the diagram below.

the source (proportioned based on the resistance of each path), and in this case the ground connection is poor or missing, the current can pass through a person touching this object and another object which is in electrical contact with the water (like an engine block, strainer, shaft, etc.). Once in the water, the current will find its way back to the source because where the green ground wire is attached to the source at the transformer, it is also staked into the Earth as a *ground* connection required by NFPA 70. In the case of a marina, this fault current can get back to the source through the water and soil until it reaches the ground stake, or, it can also get back through the underwater fittings of other boats connected directly to the green ground wire ashore.
